AVIATION INVESTIGATION REPORT A17O0025

Runway excursion

Air Canada
Airbus Industrie A320-211, C-FDRP
Toronto/Lester B. Pearson International Airport, Ontario
25 February 2017

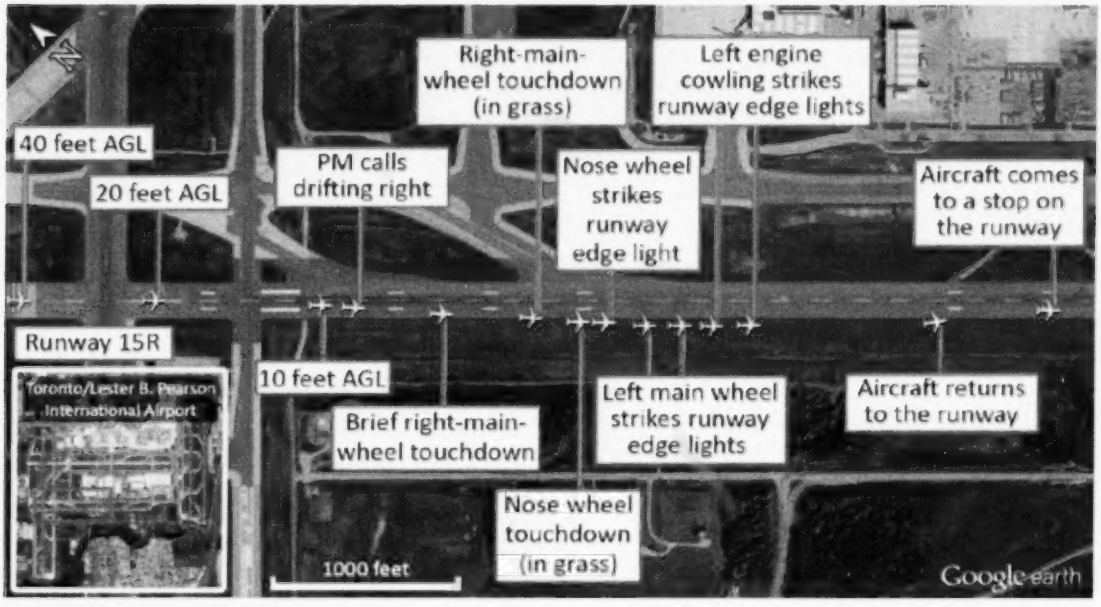
As the aircraft continued to move laterally to the right, the nose wheel touched down on the grass, approximately 280 feet beyond the final right-main-wheel touchdown point, and struck 1 runway edge light. The outboard left main wheel and left engine cowling then each struck 2 runway edge lights, and the outboard left tire was punctured and deflated.

The PF engaged reverse thrust, and the aircraft engines began to ingest debris. Once the speed had been reduced, the PF steered the aircraft back onto the paved runway surface, then came to a stop 5422 feet from the displaced threshold (Figure 1). The aircraft had travelled 2390 feet through the grass.

Figure 1. The aircraft's track from 20 feet AGL until it came to a stop on the runway (Source: Google Earth, with TSB annotations)

Right-main-wheel touchdown (in grass)
Left engine cowling strikes runway edge lights
40 feet AGL
20 feet AGL
PM calls drifting right
Nose wheel strikes runway edge light
Aircraft comes to a stop on the runway
Runway 15R
Toronto/Lester B. Pearson International Airport
10 feet AGL
Brief right-main-wheel touchdown
Left main wheel strikes runway edge lights
Aircraft returns to the runway
Nose wheel touchdown (in grass)
1000 feet
Google earth

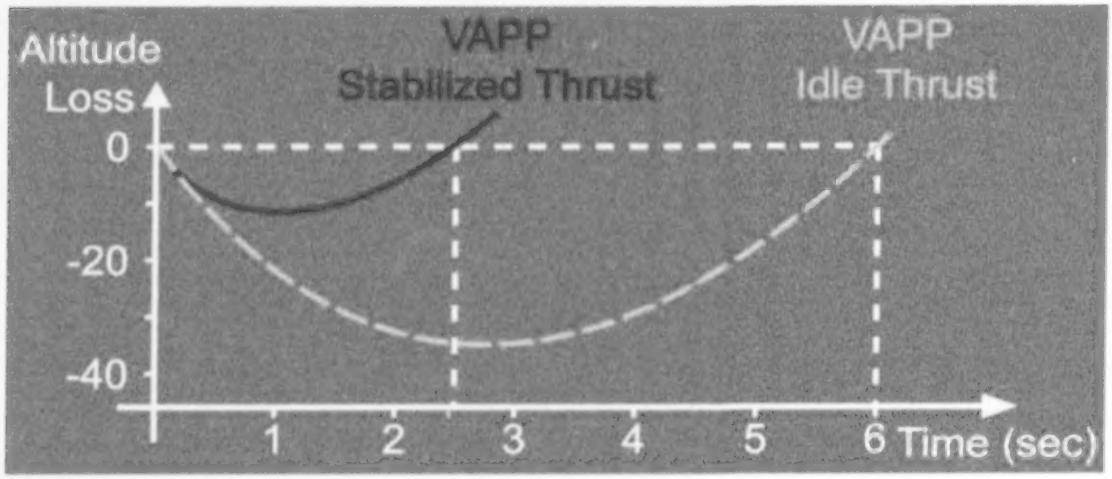
The loss of altitude is approximately 10 feet when the thrust is stabilized, but can reach up to 40 feet when the thrust is at idle power (Figure 2). As shown in the figure, if a go-around is initiated at idle thrust and approach speed, it may take up to 3 seconds to achieve a positive rate of climb, and up to 6 seconds to reach the altitude where the go-around was initiated.[7]

Figure 2. Altitude loss following a go-around (Source: Air Canada, *Airbus A319/A320/A321 Flight Crew Techniques Training Manual*, Normal Operations – Standard Operating Procedures – Go Around [05 September 2017], p. PR-NP-SOP-260 P 5/6.)
